Technical Note N-1217

AIRFIELD PAVEMENT CONDITION SURVEY,
USNLF MONTEREY, CALIFORNIA

H. Tomita and L. J. Woloszynski

January 1972

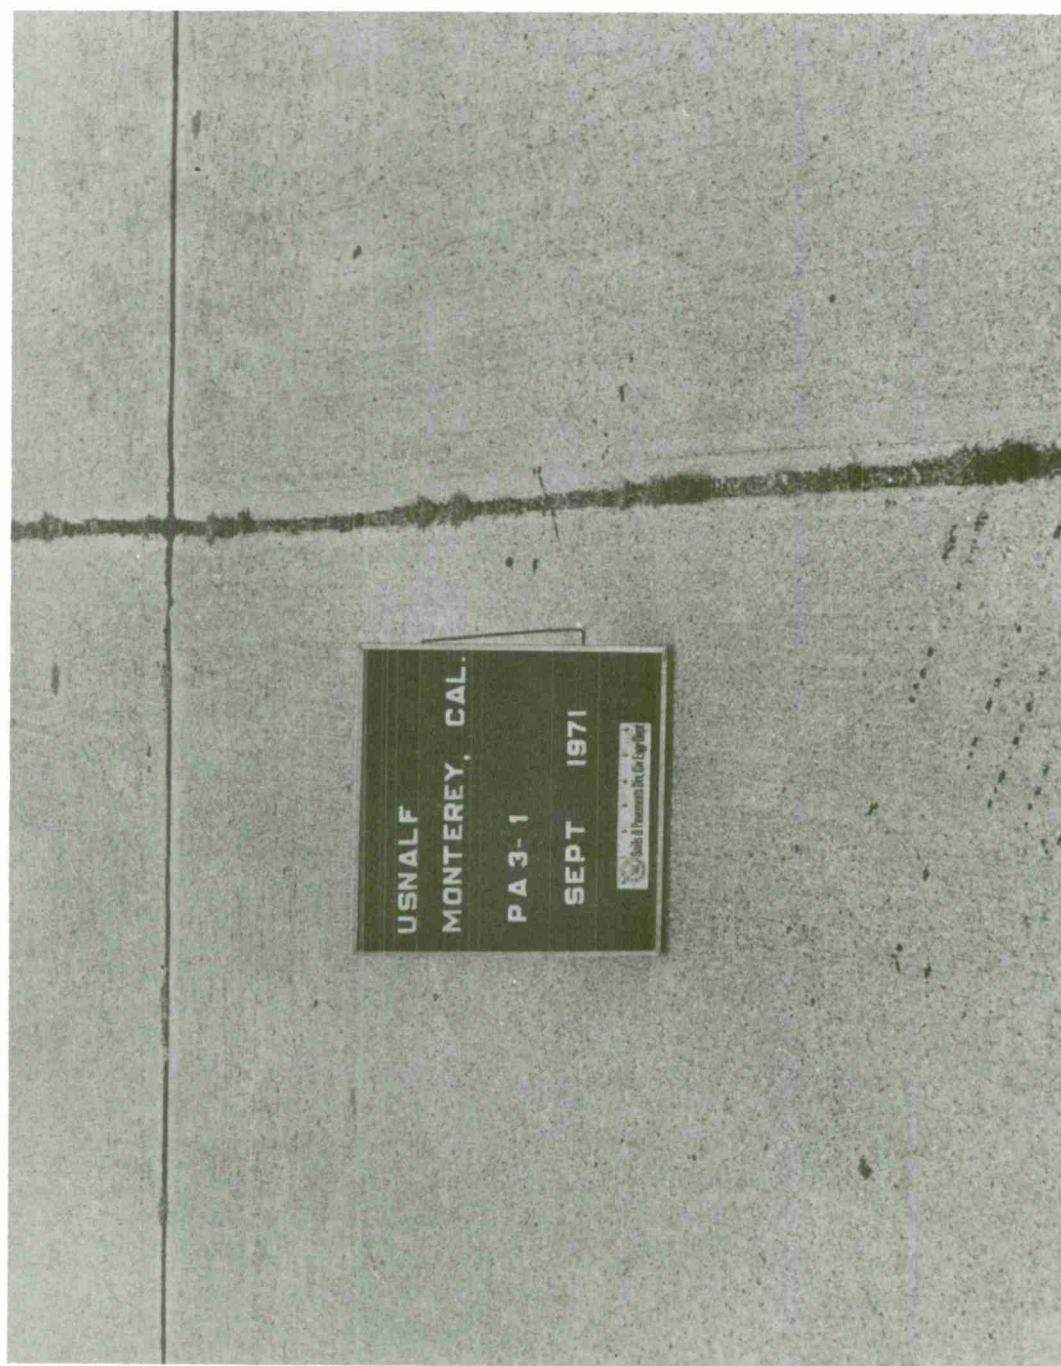
Figure 19. Vegetation growing through joint, Discrete Area PA3-1.
